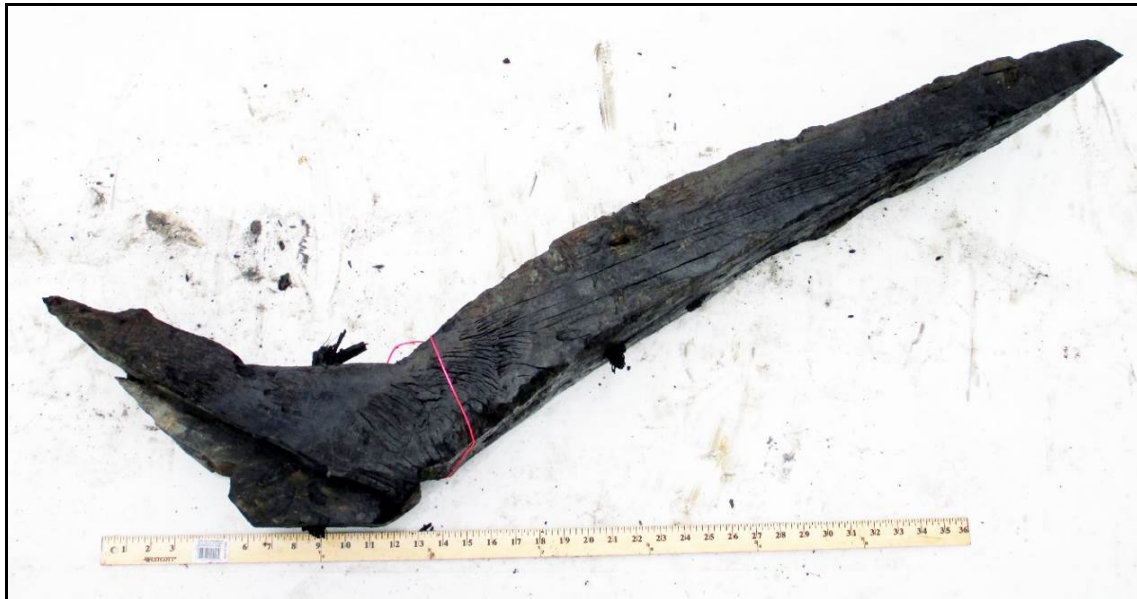
**Figure 44. Floor NR-FL05.**

keelson notch (**Figure 44**). NR-FL05 is unique from the other floors in that it has a deep notch cut into its aft face (**Figure 45**). The purpose of this notch is unclear, but it may have been an adjustment to account for a mistake in the construction or a post-construction repair.

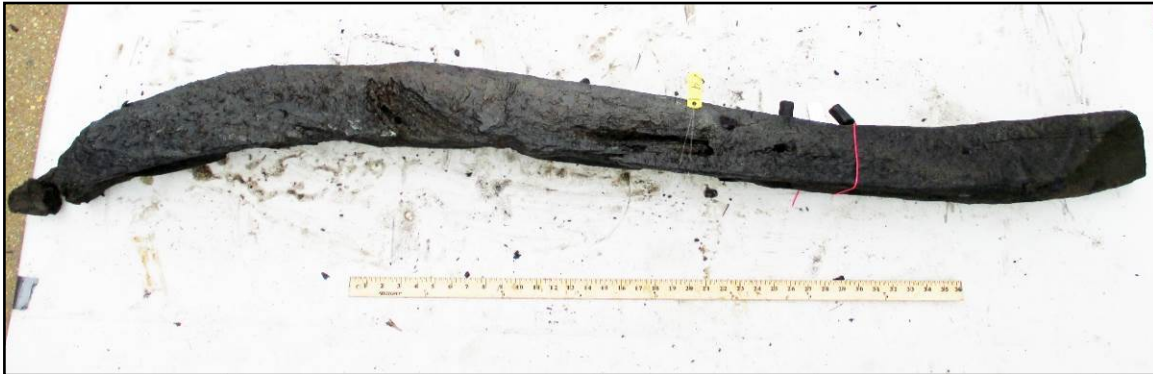
Figure 46. Futtock NR-FK04.

Futtock NR-FK04 is unique in its curvature and likely represents a futtock incorporated into a stern frame (Figure 46). This futtock has an “S” shape and may be more indicative of a cant frame that helped fashion a transom stern (Figure 47). SEARCH archaeological divers may have encountered a transom piece (see Figure 47) on the river bottom during the Phase II investigation; however, it was pinned beneath modern debris and could not be recovered safely. In addition to outer strake fastenings, NR-FK04 has a single fastener indicating a ceiling

plank was once attached. This fastener, unlike those in the remaining futtocks, is a treenail approximately 2 ft (0.6 m) from its heel and likely attached the first ceiling plank. Because of the type and position of this fastener, it could be inferred that this futtock originally was fastened either closer to the keel than other futtocks or against the deadwood in order to help shape the narrower stern.

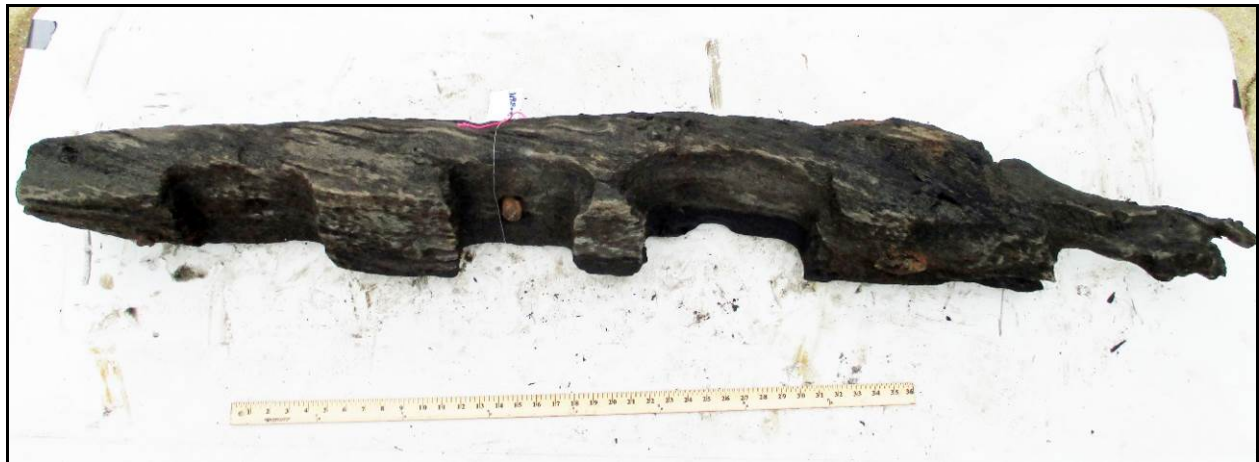
**Figure 48. Apron.**

The apron, which was cut from a curved compass timber, is disarticulated from the remains and measures 5 ft, 3 in (2.3 m) long (**Figure 48**). Based upon the fastening pattern to the keel, the apron sat atop the keel and partially atop the lower stempost. It was attached to the keel with two blind driftpins and one possible through bolt. The forward-most fastener was driven through the lower stempost beneath the apron and into the keel. Iron corrosion on the keel and lower stempost make it impossible to determine if this is the same through bolt driven through the keel described above. The middle driftpin is driven obliquely through a notch cut for a floor, and has a clinch ring; SEARCH cannot determine whether the third fastener includes a clinch ring due to iron corrosion. The apron varies in the molded dimension from 3 to 8 in (7.6 to 20 cm) due to its curvature. It is relatively uniform in its sided dimension at 7 in (18 cm) for the first 3 ft (0.9 m), at which point it tapers towards the forward end; therefore, it is wider than the keel by approximately 3 in (7.6 cm) for the first 3 ft (0.9 m). The forward end appears broken and originally may have curved further along the stempost. Alternately, the apron may have been segmented with multiple timbers to form the upward curve.

The apron is notched on its upper face to accept three floors. The notches average 6.5 in (17 cm) wide and are approximately 2 in (5.1 cm) deep. The aft notch contains a through treenail that penetrates the keel as part of the fastening for the missing floor. The center notch has a hole drilled through the apron for a non-existent treenail, which is offset from the driftpin that attaches the apron to the keel; there is no corresponding hole in the keel suggesting this floor

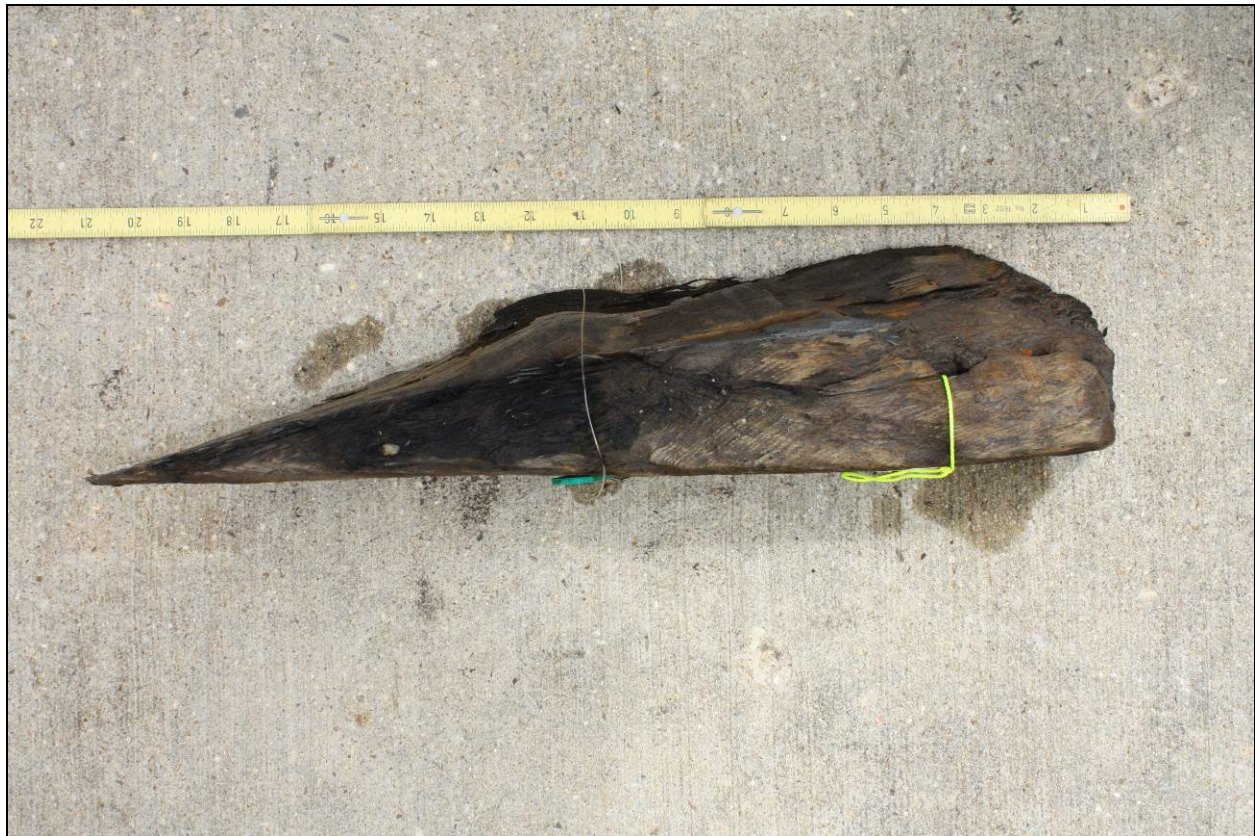
Figure 49. Triangular chock.

originally was attached only to the apron. There is one through treenail driven athwartships at the forward end, one blind treenail in the lower aft port corner, and one blind treenail in the lower starboard face to attach hood ends of the garboard strakes to the apron. SEARCH documented two triangular chocks that could have been utilized beneath the bow floors, perhaps those originally attached to the apron, in order to help support the increased deadrise (Figure 49).

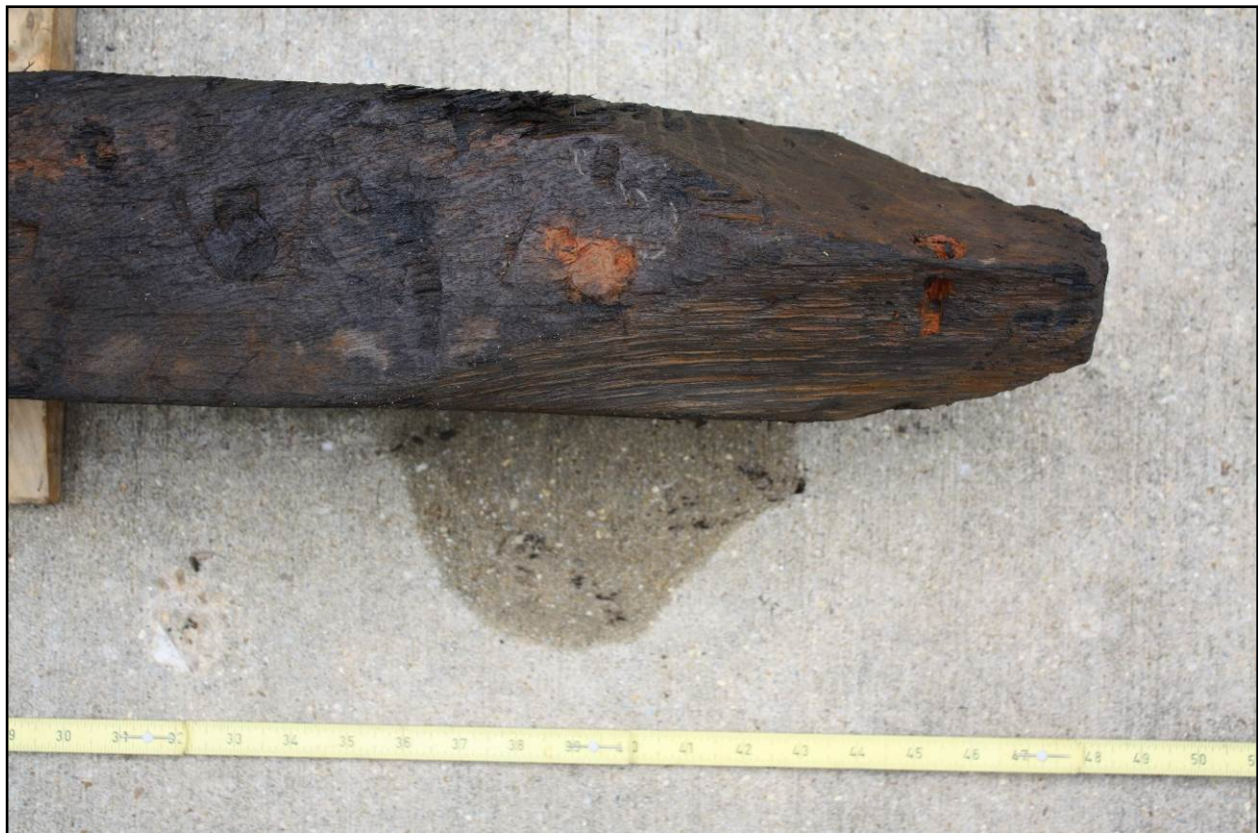
**Figure 50. Heel end of possible cant frame.**

One recovered timber could be the lower component of a bow cant frame. This timber resembles other first futtocks in its curvature and size – 4 in (10 cm) molded, 5 in (13 cm) sided, and 4 ft (1.2 m) long – but unlike other futtocks it is chamfered on both forward and aft upper faces of its heel (**Figure 50**). This construction would prohibit faying the timber parallel to a floor; rather, the timber likely fastened against at least one other timber with a cant (e.g., apron), and perhaps in the crotch of two timbers (e.g., between the first square frame and the apron). The resulting cant of the timber created by the chamfer would negate the need to bevel the outer face of the timber in order to create a tight fit of the plank against the frame. The oblique angle of multiple cant frames form the bow of a wooden hull vessel (**Figure 51**).

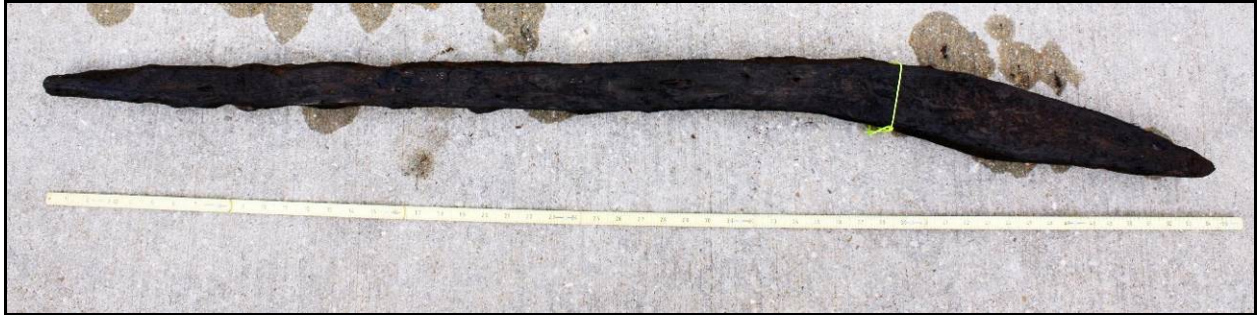
Figure 52. Unknown timber.

Archaeological divers recovered a complete timber from the river bottom that may have originated in the bow (**Figure 52**). Its shape somewhat resembles a futtock, but its size is too meager to act as a frame component. The timber is sided 2.5 in (6.4 cm) at one end and tapers to 1 in (2.6 cm), and molded 3.5 in (8.9 cm) for the first third then quickly tapers to 2 in (5.1 cm). It also does not have evidence of extensive fastening, with only the remains of three treenails grouped close to one end. One end is cut at an angle in its upper face tapering its molded dimension. It resembles a gripe; however, the fastening remains do not match the blind bolt driven into the forward face of the lower stempost, nor do the curvatures of timbers coincide, so this is an unlikely description. It is possible this timber is a component of the knee of the head or the stem, perhaps an inner stempost.

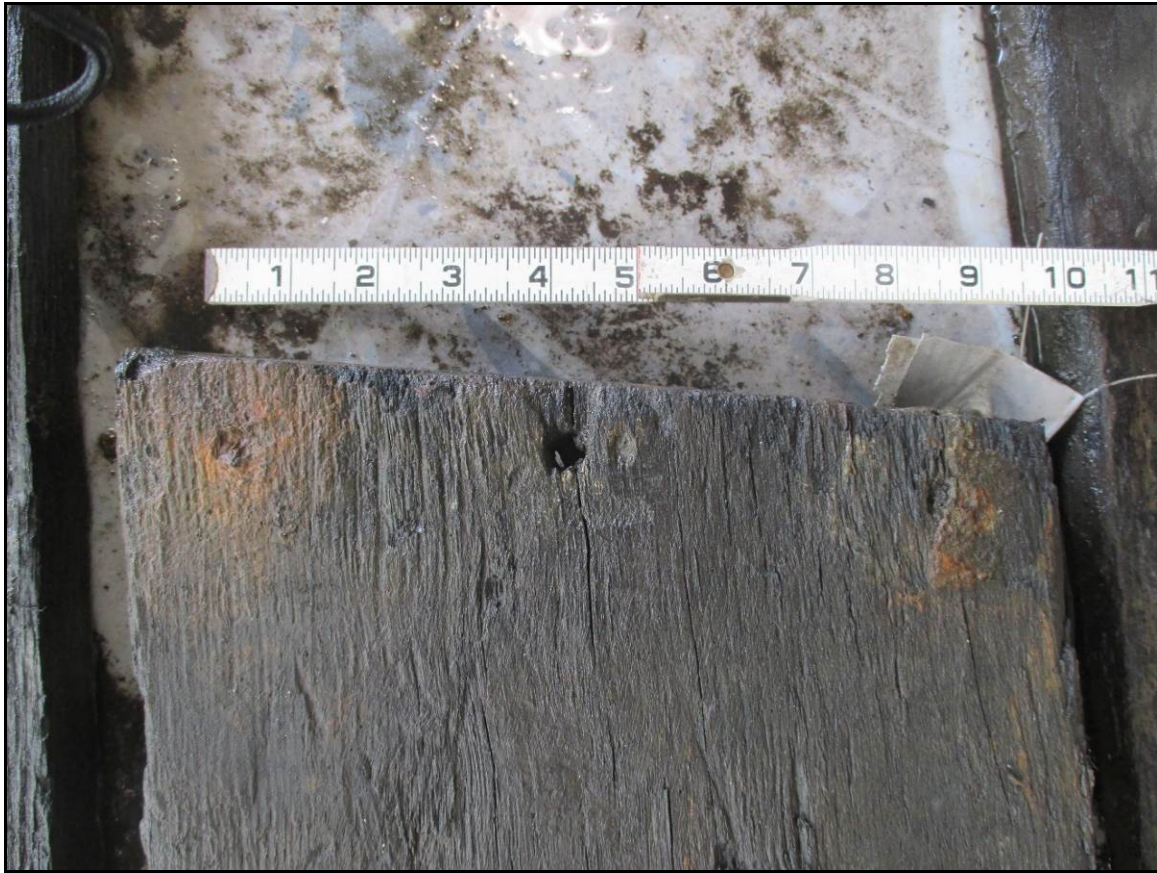
Figure 53. Fastening at end of strake.

Nine strakes originally were attached to both the floors and first futtocks at each frame station. The fastening pattern among these strakes is random, with an average of three fasteners per frame station. Either treenails, square iron nails, or a combination of both attached the strake to the floor, first futtock, or both timbers at each frame station. Desmond (1919:59) states that treenails resist transverse strains better than metal, while metal better resists direct separation; therefore, it is important to utilize a combination of both to secure outer hull planking. Three square iron nails attached the ends of strakes to one frame timber (**Figure 53**). The spacing between fasteners of seven strakes is large enough for the strake to originally have been attached to only one component of each frame station. Two strakes are too degraded to determine a fastening pattern.

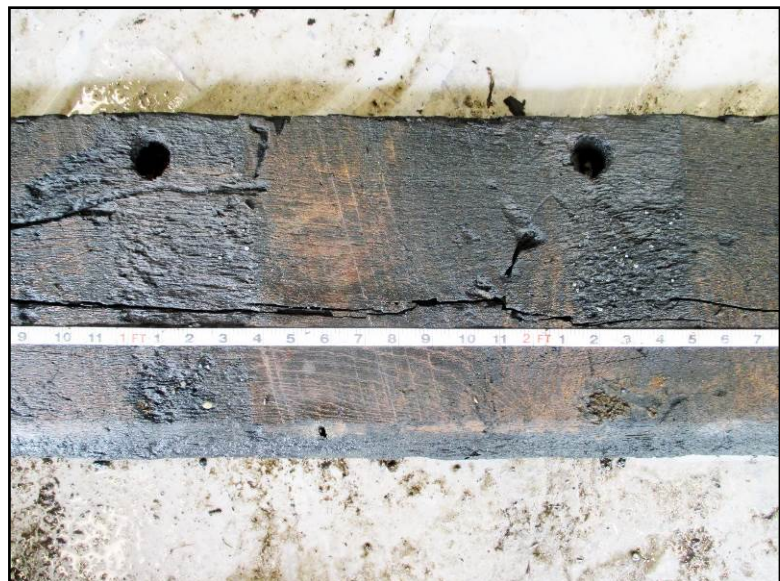
Three planks are confirmed as garboard strakes due to a beveled edge designed to mate with the keel rabbet (**Figure 54**). The garboard strakes originally were attached to the majority of floors with one treenail driven 2 in (5.1 cm) from the top of the plank and at least one wrought iron nail driven just above the bevel (i.e., single fastening at approximate 13-in [33-cm] intervals). The single fastening pattern is altered at seemingly random frame stations with additional nails added and sometimes treenails omitted. It is evident from frame impressions on the garboard strakes that these planks attached

Figure 54. Inner face of garboard strake. (Note: the rabbet bevel, pit saw marks, and wear patterns where the strake would have been attached to floors.)

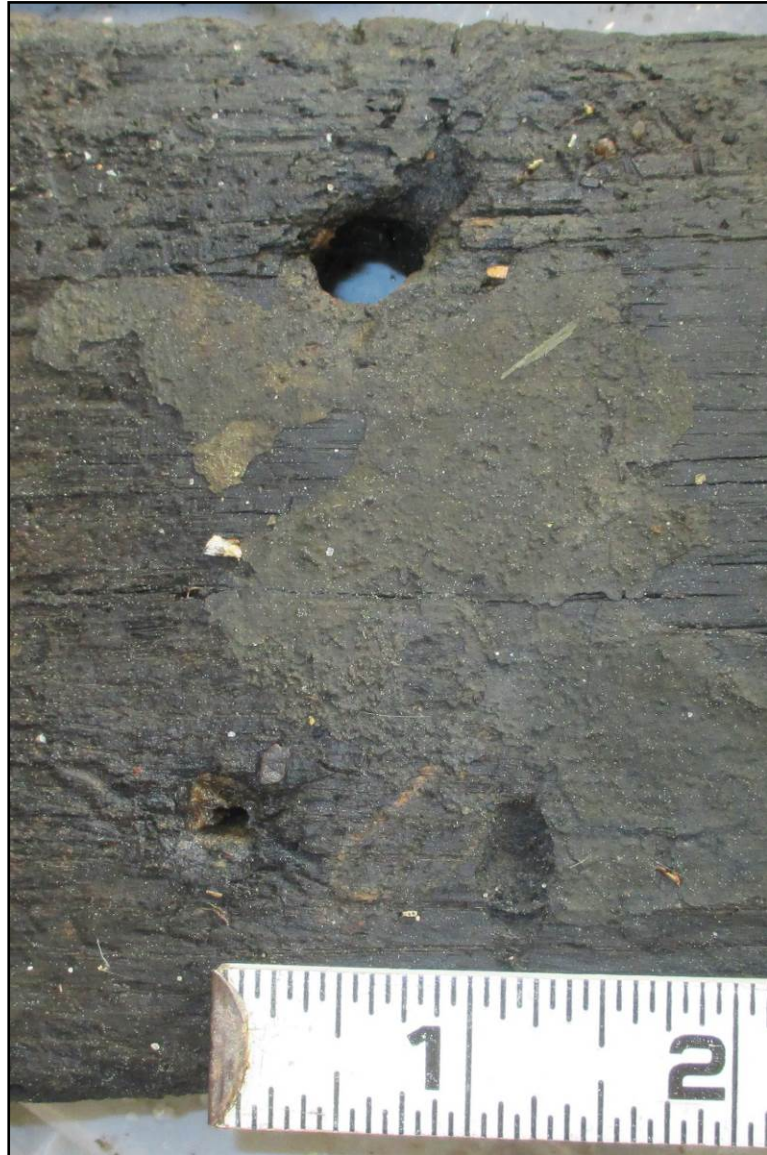
**Figure 55. Thin metal layer on strake.**

A relatively thin layer of metal resembling lead covers a small portion of a strake (**Figure 55**). A sample of this substance was submitted to the Archaeology Institute at the University of West Florida for chemical analysis with a Bruker Tracer III-SD pXRF spectrometer. The sample chemical composition is mainly iron, but did test positive for a relatively small amount of lead (Carroll, pers. comm. 2015). The amount of lead is not significant enough to indicate the presence of lead paint on the wood; SEARCH is uncertain the origin of this material. One possibility is the layer of ferrous alloy was transferred to the strake by an iron fastener, or a disarticulated iron artifact associated with the shipwreck, such as a deadeye. Finally, one strake shows evidence of post-construction repair in the form of a 3-x-11-in (7.6-x-28-cm) patch (**Figure 56**).

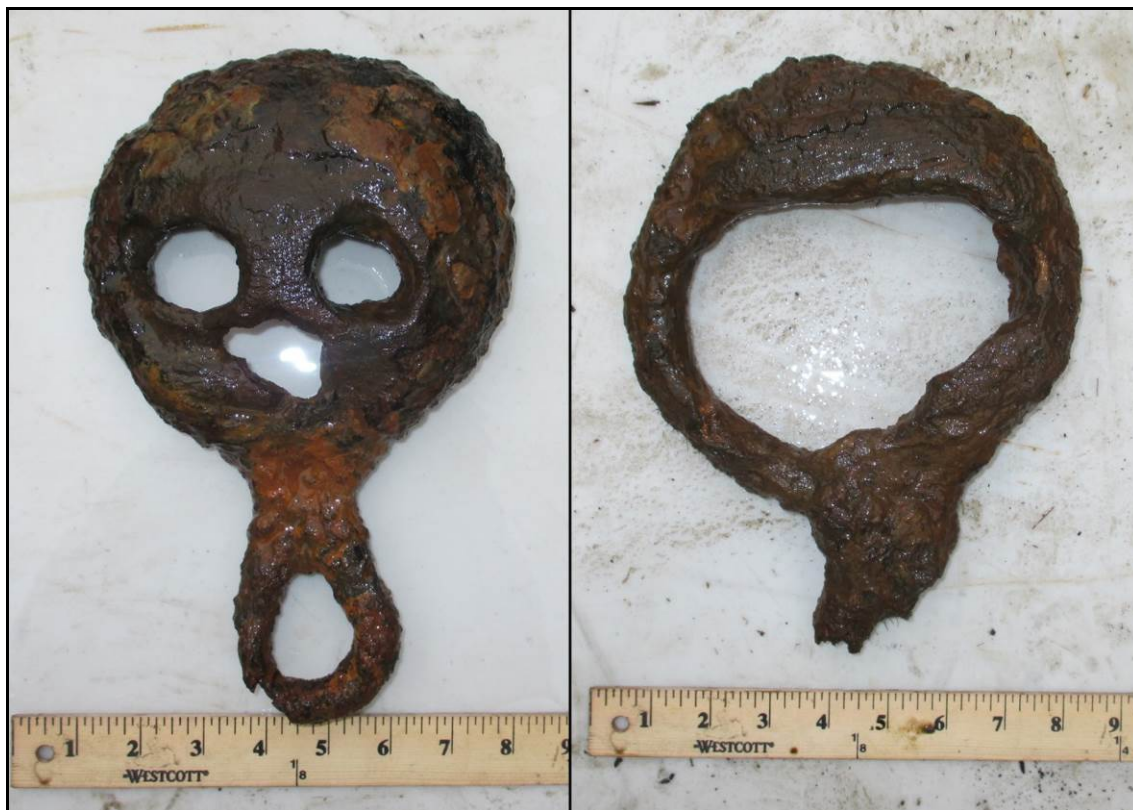
Figure 57. Deadeyes.

The remains of two deadeyes were recovered from the river bottom (**Figure 57**). They are both iron-bound chain deadeyes—meaning they are the lower blocks in a shroud pair—that originally would have attached to chainplates (**Figure 58**). One deadeye is near complete with much of the wood block extant and the entire wrought iron circular strap still resting in the block groove with the upper link of the chain assemblage intact. The second deadeye is missing the majority of the block and upper link of the chain assemblage. The more intact deadeye has three holes to accept a lanyard; there exists some evidence in the wood that the holes were scored to help prevent twisting of the lanyard. One measures 6.5 in (17 cm) in diameter and the second 7.5 in (19 cm) in diameter, with concretion. Three hand-formed bricks were recovered from the river bottom, one of which bears indiscernible markings (**Figure 59**). Bricks could have been utilized onboard for a small hearth. Ballast is another potential use; however, few bricks were recovered from Site 18DO497 indicating this is an unlikely identity, unless salvage of the Nanticoke River Shipwreck occurred.

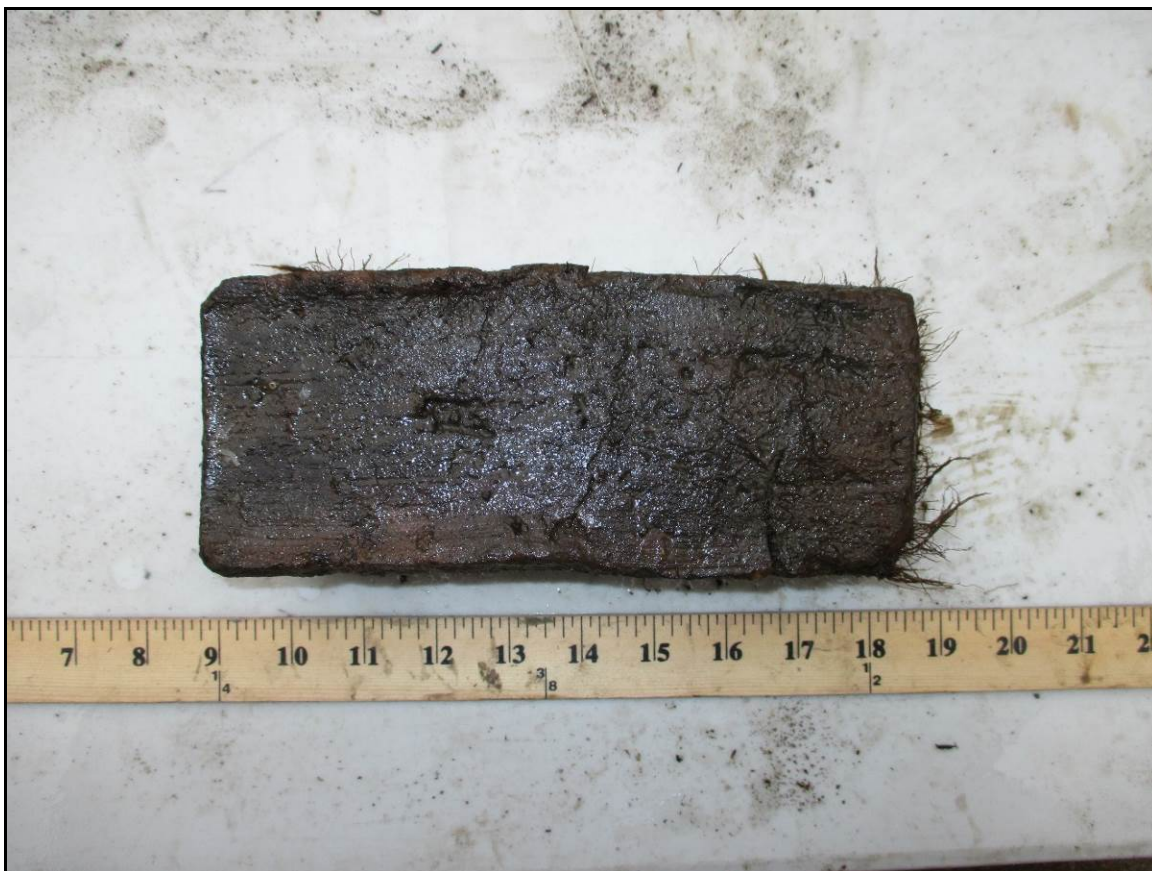
Figure 59. Brick.

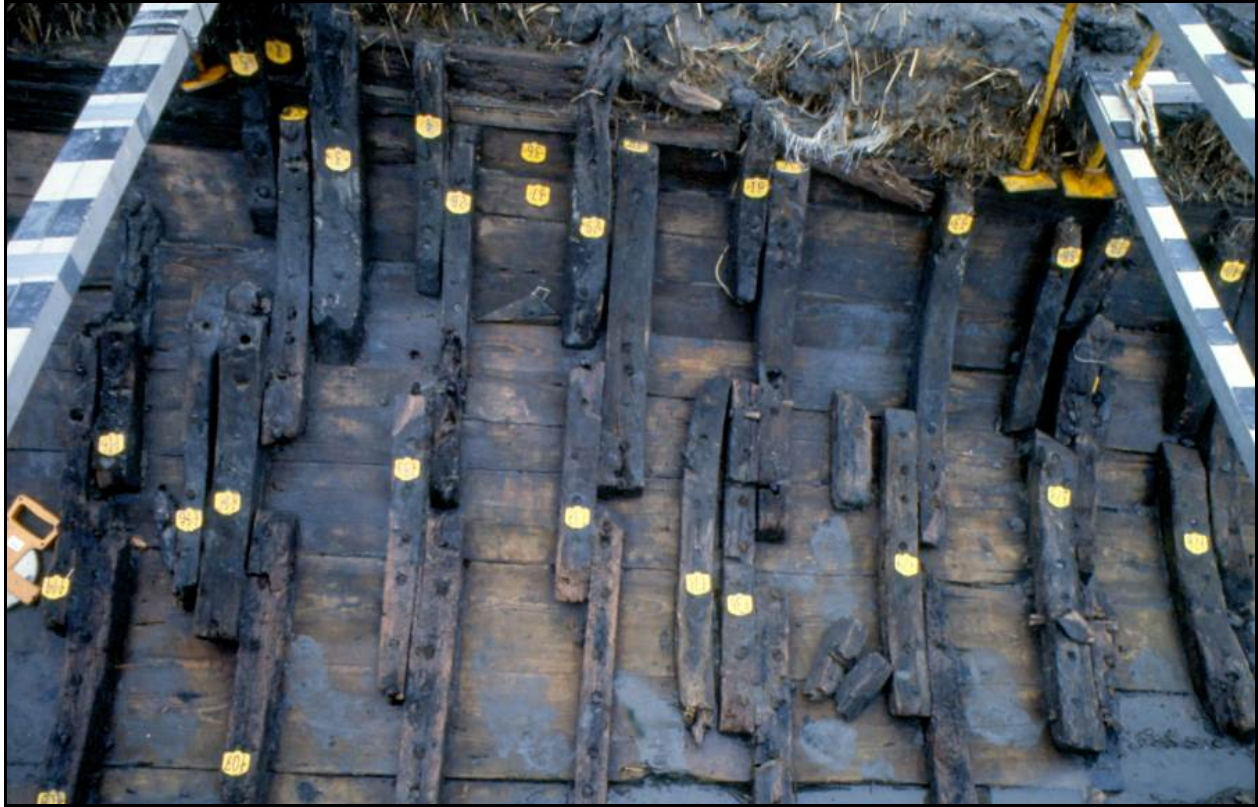
Figure 64. Malcom boat (38CH803) frames. (<http://artsandsciences.sc.edu/sciaa/mrd/malcolmboat>)

The Malcolm boat (38CH803) excavated near Charleston, South Carolina in 1992 has been dated between 1775 and 1825 (Amer et al. 1993:ii) (**Figure 63**). It has been estimated at nearly 42 ft (13 m) long on deck by nearly 12 ft (3.7 m) in beam, with a depth-of-hold almost 5 ft (1.5 m). The framing pattern resembles that of early single framing described above and that of the Nanticoke River Shipwreck. The 22 square frames along the keel consist of floors fastened to the keel and keelson with single treenails, first futtocks fayed to the forward side of the floor with the heels between 14 and 22 in (36 and 56 cm) from the edge of the keel (Amer et al. 1993:49). Second futtocks are fastened in line with the floors and third futtocks in line with the first futtocks; gaps exist between all components (**Figure 64**). Additional futtocks were added in space where needed and components of select frames are laterally fastened with treenails. Another feature that Site 18DO497 shares with the Malcolm boat (38CH803) is the shape of the keel. Not only does the Malcolm boat (38CH803) keel taper towards the stem, but it also had no protective shoe and is rounded on its bottom “suggesting that the natural shape of the tree was incorporated into the shaping of this timber” (Amer et al. 1993:46).

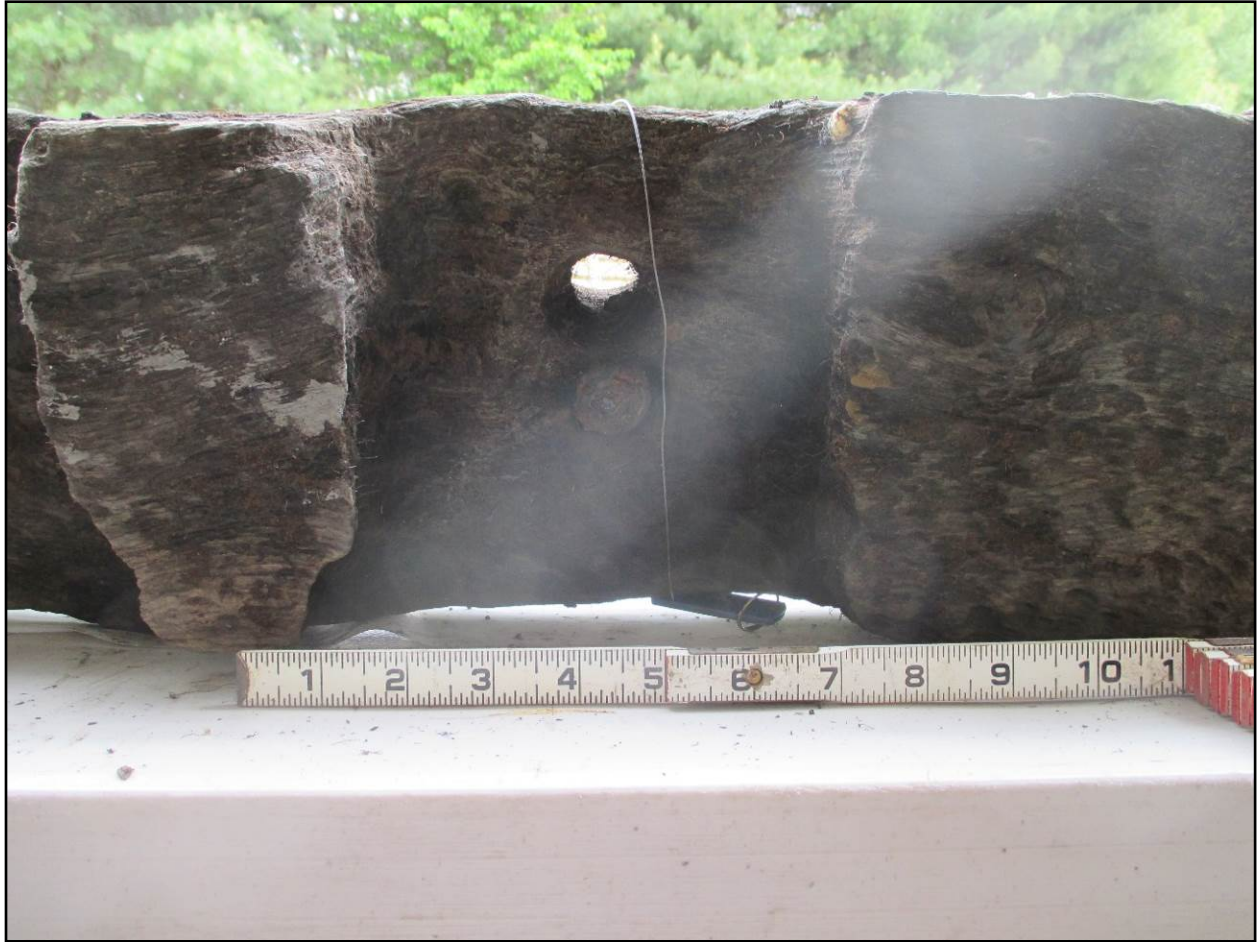
**Figure 77. Apron and floor fasteners.**

A number of clues exist to suggest the Nanticoke River Shipwreck may not have been professionally constructed, but instead originated on a plantation or rural creek. It has not been determined how the sternpost originally attached to the vessel. Perhaps the post was fastened fore-and-aft to the aft face of a second deadwood timber with additional support in the form of gudgeon straps. The lack of lower fastening, however, certainly weakens the post integrity. Other haphazard techniques recognized on the Nanticoke River Shipwreck include: the failure to completely cut away the sternpost scarf, the ill-formed garboard rabbet on the apron, the floor in the apron notch that was attached to neither the keel nor keelson, and a treenail hole for an apron floor drilled immediately adjacent to a driftpin fastening the apron to the keel (**Figure 77**). Other construction attributes question the materials available to the Nanticoke River Shipwreck shipyard, such as the absence of fishplates attached to the sternpost or the stempost and the reliance upon wood fasteners when attaching heavy timbers that typically require long bolts and drift pins (of the 20 floors attached directly to the keel,

potentially only 40 percent are attached with iron drift pins) draws into question the materials available to the Nanticoke River Shipwreck builder. These choices could imply that either the shipyard did not have access to the requisite iron hardware or lacked the capital to purchase a sufficient supply. Established, professional shipyards certainly had access to iron materials, since a sufficient number of foundries had developed in the Colony by the middle of the eighteenth century to supply local shipbuilders (Ford 2002:82).

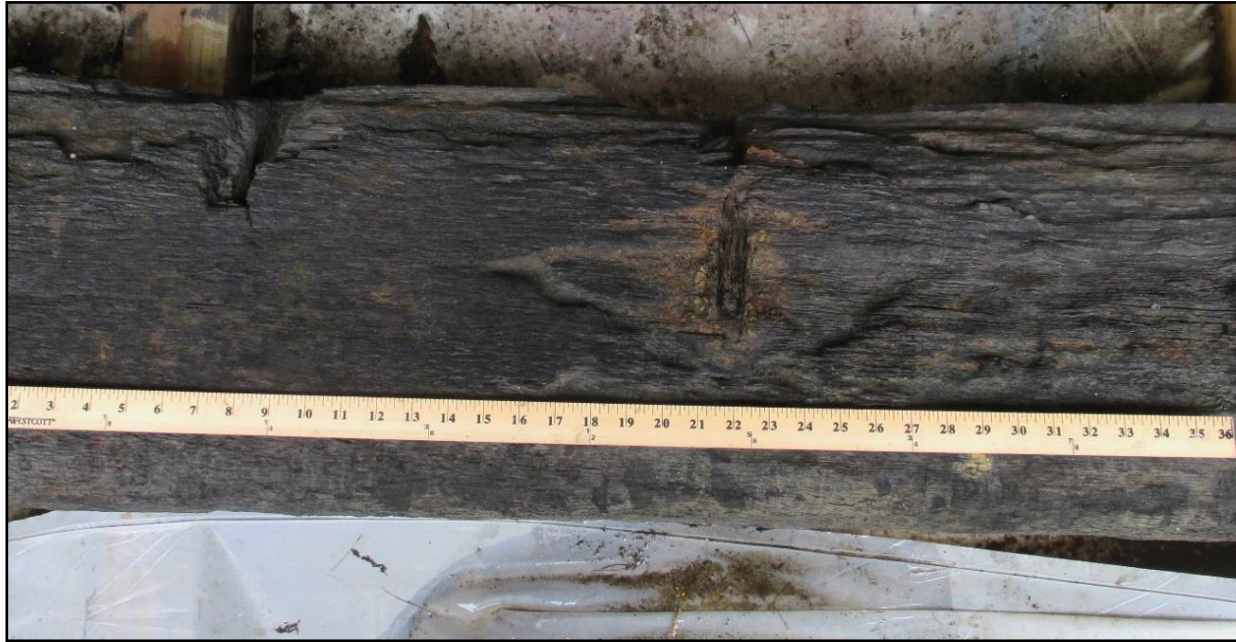
Figure 78. Exposed drift pin at the edge of the keel.

Several floors were left unattached to the keelson, which weakens the backbone of the vessel, and it appears that two floors had a second fastener driven through them. In one instance, it appears that a floor was improperly placed, removed and repositioned, and reattached with a new fastener. Another floor appears to have originally been fastened with a driftpin driven so close to the edge of the keel that it was exposed (**Figure 78**). A second driftpin was driven through the floor and closer to the center of the keel. As previously noted, the deep notch cut into floor NR-FL05 could indicate a possible mistake in the shaping and/or installing of this timber, and subsequently, the builder's attempt to install a supplemental timber to compensate.

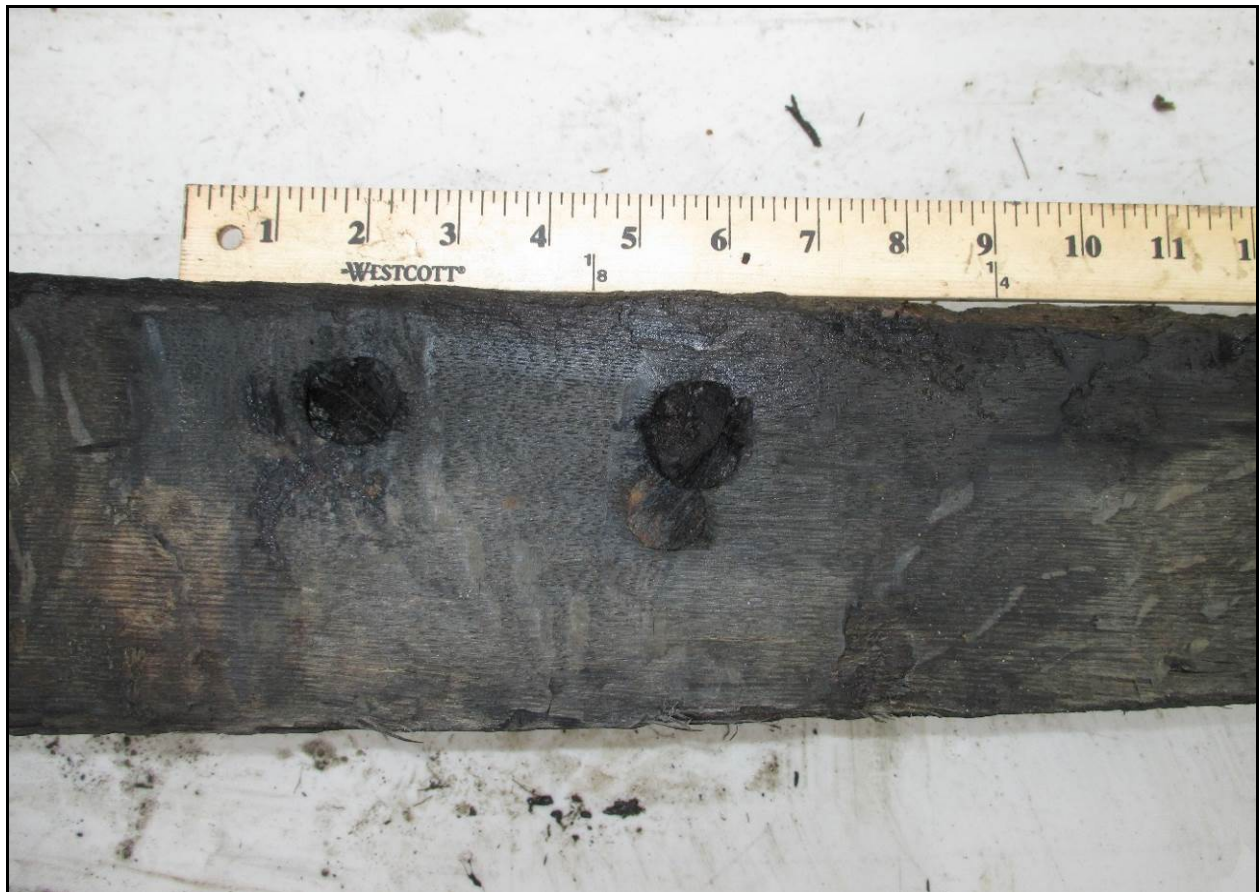
Figure 83. Example of refastening (center of photo).

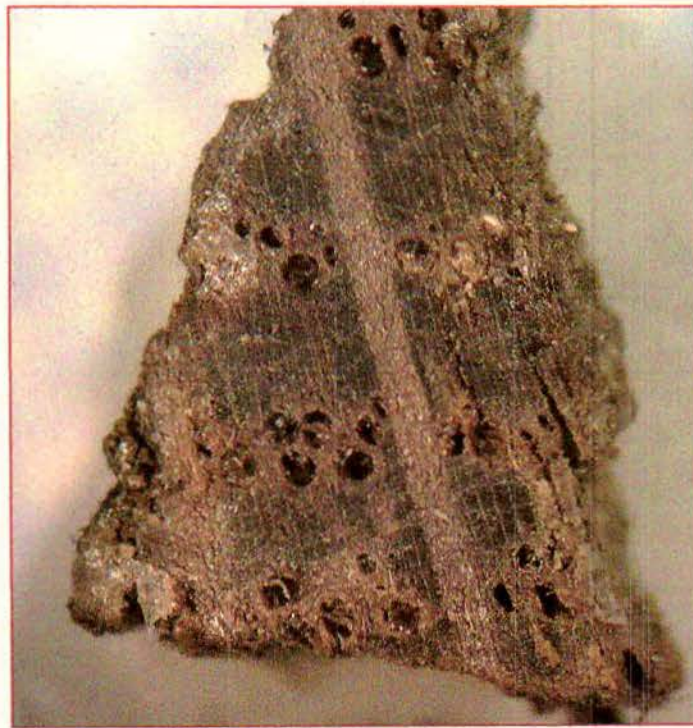
**Figure 1: White oak structure is clearly evident under magnification. (Keelson).**

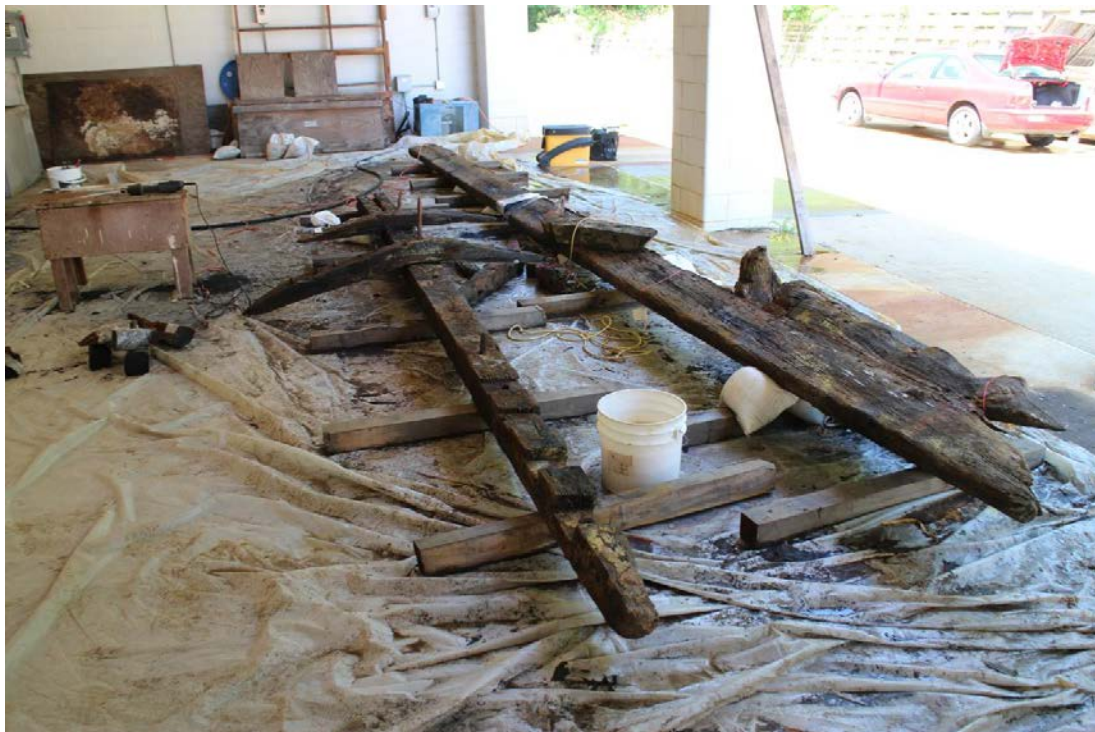
**Figure 9.** Photograph of keelson (left) and keel (right).
