# Vienna's Nanticoke River Shipwreck

Prepared for the Vienna Heritage Society

| Topic | Description |
|---|---|
| Detailed Report | <i>Phase I and Phase II Underwater Archaeology Investigations of the Nanticoke River Shipwreck (Site 18DO497)</i> by SEARCH for State Highway Administration, Project AX744A55 (2017) |

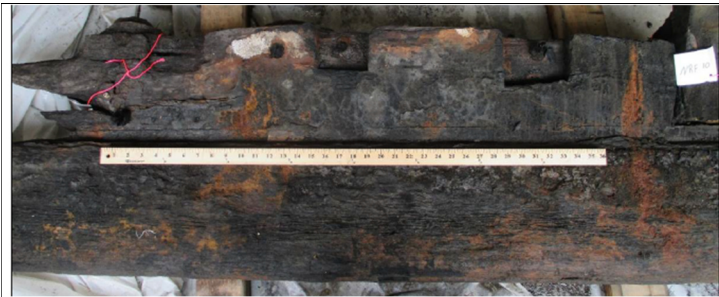
Deadwood Stern & Keel fragments

The deadwood has three notches in both its port and starboard faces to accept half frames (notches on the port side are eroded). A one-in treenail is driven athwartships through the lower, aft corner of the deadwood just above the keel rabbet, which shows **evidence of charring**.

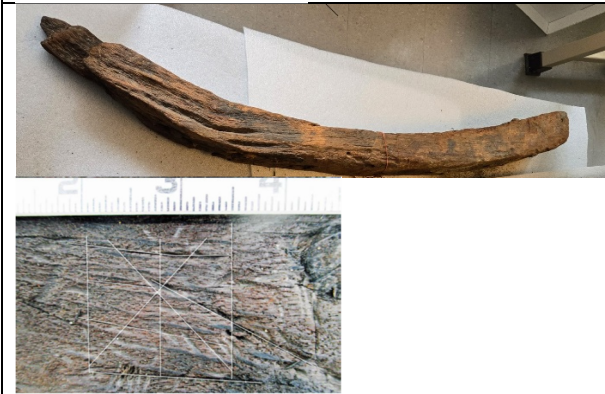
NR-FK01 Futtock

Paired with NR-FL04, this piece also has **faint markings** scrawled resembling either a Roman numeral “X” or partial asterisk within a square. It is possible these symbols denote a master frame, which provides additional evidence supporting the hypothesis that the **shipwright marked the timbers**, instead of the competing hypothesis that these were symbols designed to **ward off evil spirits**, possibly placed by enslaved people.

Figure 35. Markings on floor timbers.

Sat atop the keel, this piece matches with the lateral fastener through the chamfered end of futtock NR-FK01. Both pieces have **faint markings**.
